## ROOFING

# LEAKING ROOFS AND WALLS: WHAT'S NEXT?

By Charles Antis

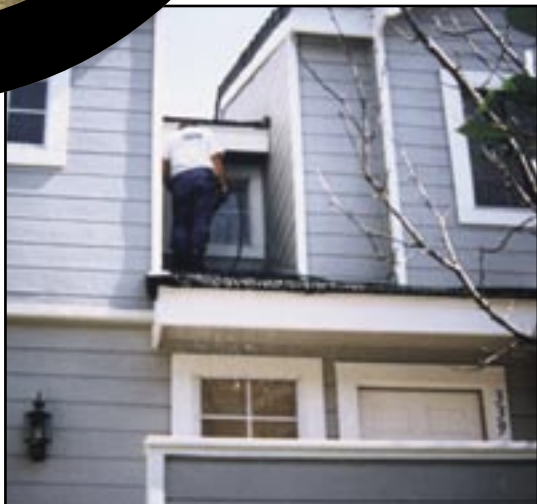
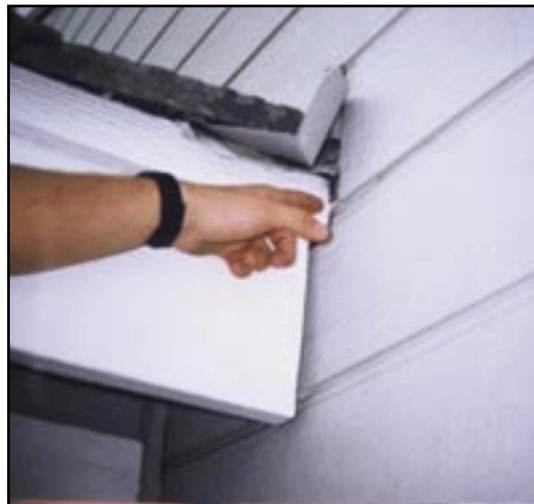
area was moved to the wall below the window, then onto the window, then to the wall up to the roof transition. On the fifth stage of testing, the leak quickly appeared.

The water testing at Summerwind started on the lower section of tile roofing. After 30 minutes with no water intrusion in the entry ceiling, the testing area was moved to the wall below the window, then onto the window, then to the wall up to the roof transition.

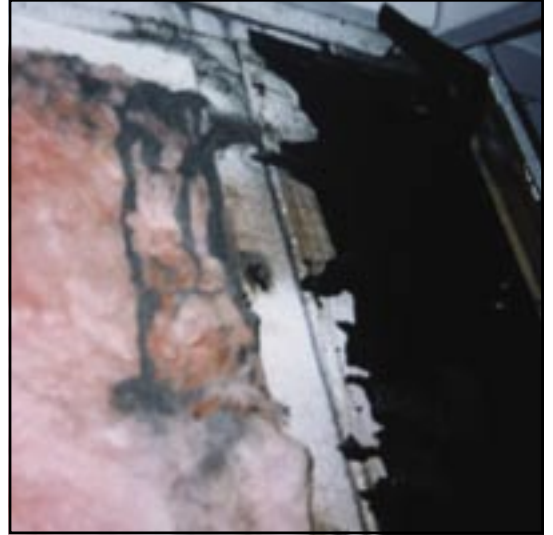
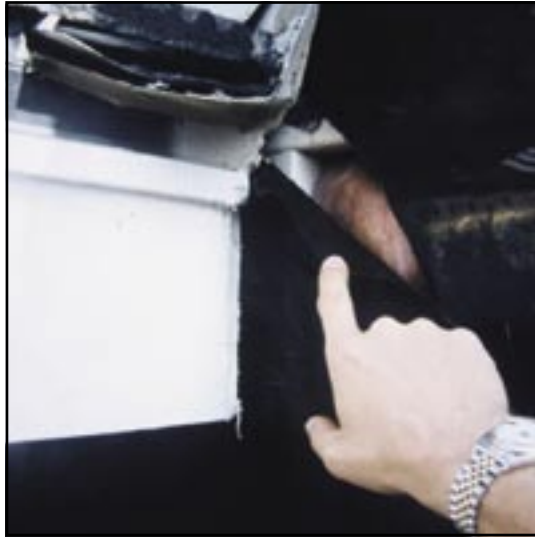
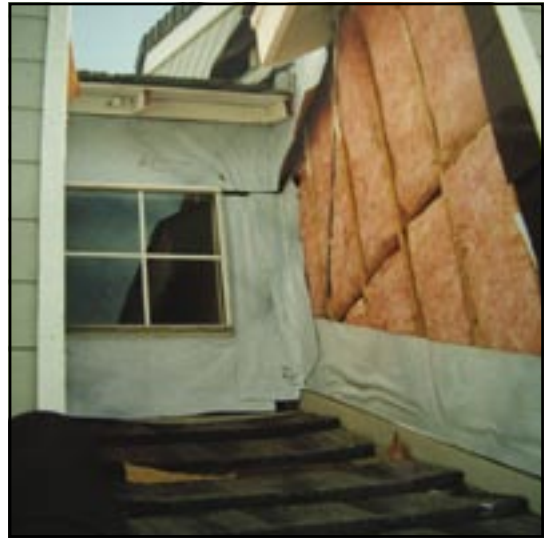
During step two, the section of flashing failure is carefully dismantled until the failure is evident. It should be understood that water-leaks always leave

substantial evidence. This is in the form of staining, heavy dirt build-up, rot and rust, which make for dramatic photographs. After identifying the failing components, the roofs or walls are reconstructed in a correct manner.

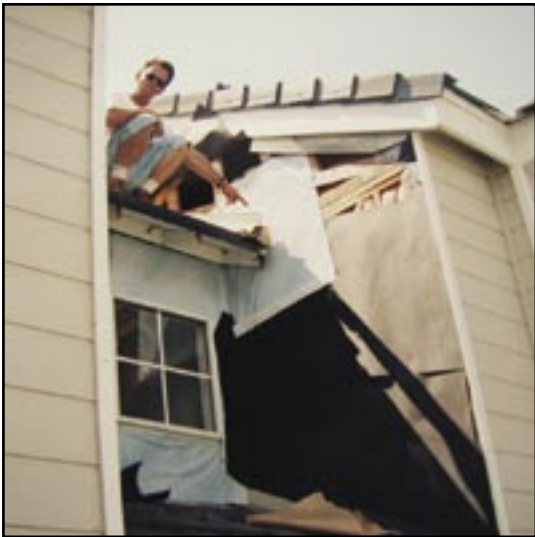
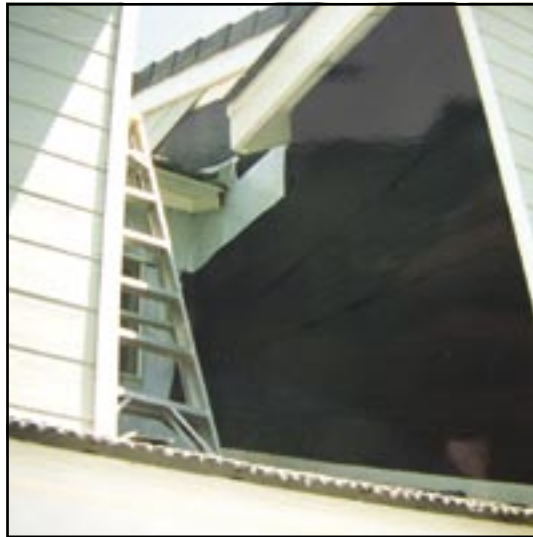
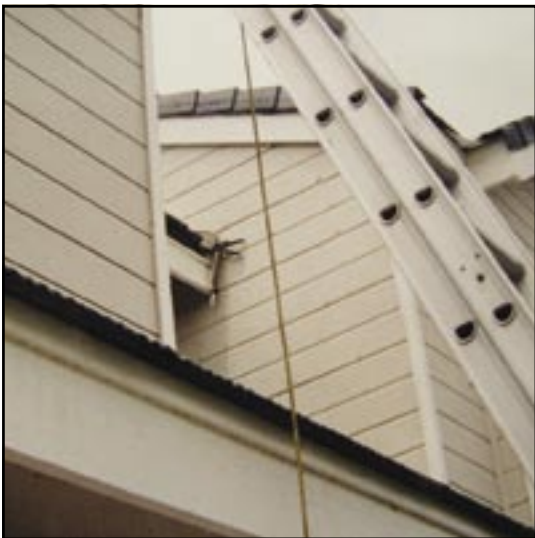
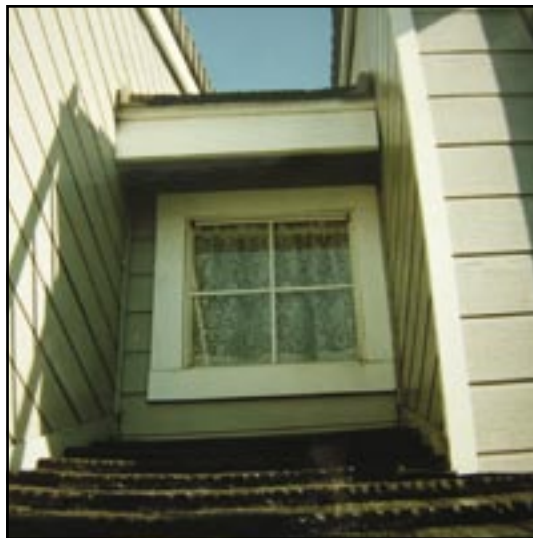
At Summerwind, when the walls and roofing-related flashings were removed, it was evident why leaking had occurred. Many of the components were not overlapped.

At Summerwind, when the walls and roofing-related flashings were removed, it was evident why leaking had occurred. Many of the components were not overlapped. Heavy soot build-up in the wall insulation caused by the filtering of air-borne pollutants in the rainwater was proof of the source.

The wall and transitional flashing area was rebuilt using upgraded #30 pound felt underlayment, and the critical transition areas were flashed using a pliable membrane called Melroll. All siding and roofing were replaced in weatherboard fashion with correct overlapping and guess what? Next storm, no leaking occurred!
