ADDRESSING STUCCO FAILURE

By Charles Antis

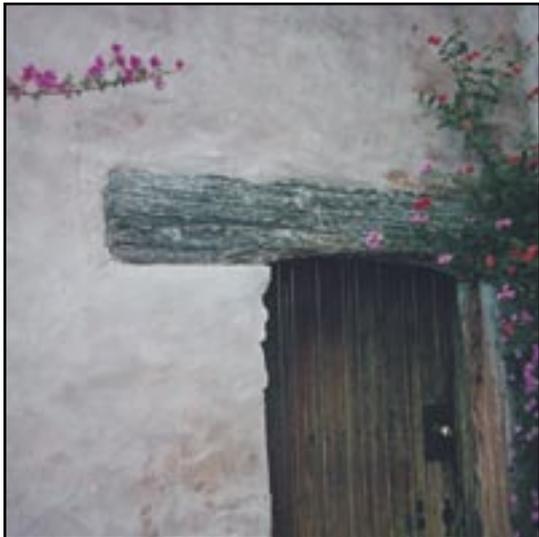
Early 1800's stucco

Stucco became popular in the United States in the early 1800's as an inexpensive and effective means of exterior wall covering over concrete, brick or

stone. Today most stucco involves a less expensive method of application; instead of brick or stone, it is applied over open frame construction. "Open frame" means that paper and lathe reinforcement resembling chicken wire is laid over wood-framed walls without sheathing, and then coated with three applications of plaster. This is a low-cost technique, but it has pitfalls.

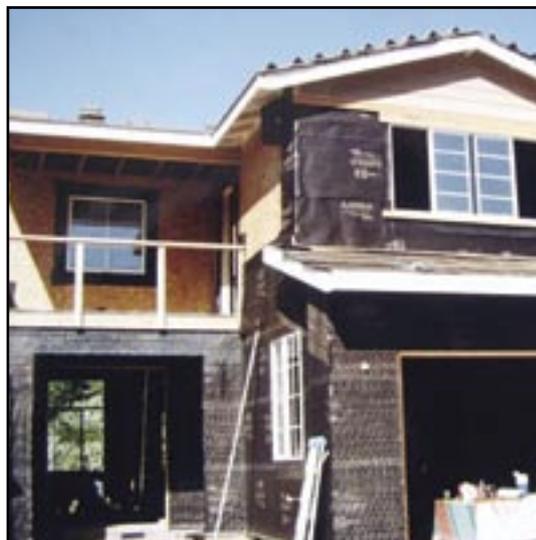
Paper behind stucco

When you look at a stucco wall, all you see is plaster. The plaster does not keep your home dry; it just protects the waterproofing paper. Yes, paper. In 90 percent of the exterior wall area, all that is keeping your unit dry is paper that is thinner than a business card. Because stucco acts like a sponge, water

gains access to the protective paper flashing and will leak into your wall cavity at any tear, backward lap or voided area of the paper.

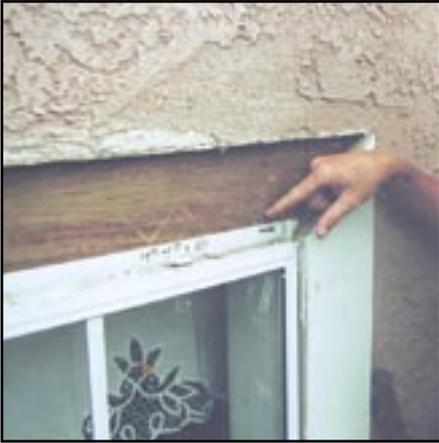
Backward lap on window

Window leaks in stucco walls are among the most common flashing failures within the entire building structure. These leaks occur from two basic sources: failure of the window frame mechanism itself or improper lapping of the stucco's protective paper system onto the window flanges. Repair commonly requires rehabilitation of the window frame or removal of stucco surrounding the window to correctly apply the paper flashing system.

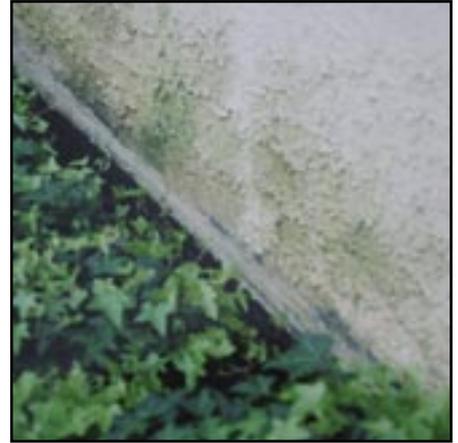
Stucco buried by planter

Even when weep screed flashing is installed, exterior planter systems are often raised to a level higher than the flashing or the interior floor line. When this occurs, water is forced into the wall structure.

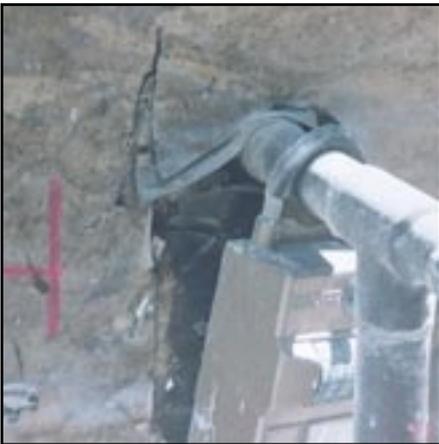
Gas conduit penetration

Vents, hose bibs, electrical outlets and light

fixtures in stucco walls create a flashing problem during construction. Most of these do not have adequate flanges to overlap the paper flashing properly and were not properly sealed during construction.

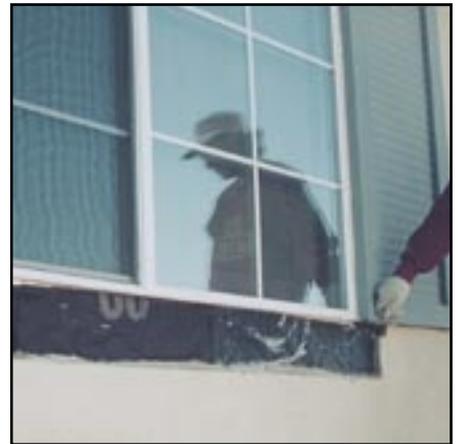
Window installation

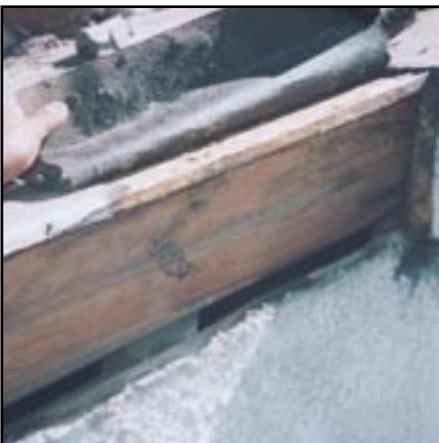
No paper under fascia

In the past, a common mistake made by builders was to terminate the paper protective system at the point of the fascia board (trim wood) located under the roofline. As the wood ages, it shrinks and splits, allowing moisture to go behind the wood and into the wall.

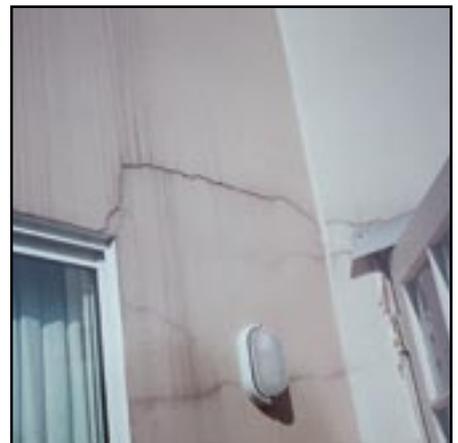
Stucco cracking

Stucco walls often exhibit cracking at windows, doors or open field areas within the wall. While cracking doesn't necessarily indicate failure of the weather-protection system, the increased exposure to rain water and air-borne pollutants cause the paper to prematurely rot and fail thereby allow moisture intrusion.

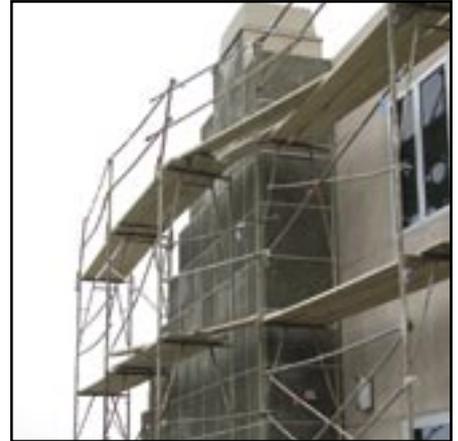
\$\$\$\$ Wall Rebuild

Completely rebuilding a 20-foot by 20-foot section of stucco wall with new flashing may cost between \$10,000 and \$23,000. Fortunately, this type of repair is seldom necessary. My own company completely rebuilds exterior walls less than 1 percent of the time when addressing stucco failure.

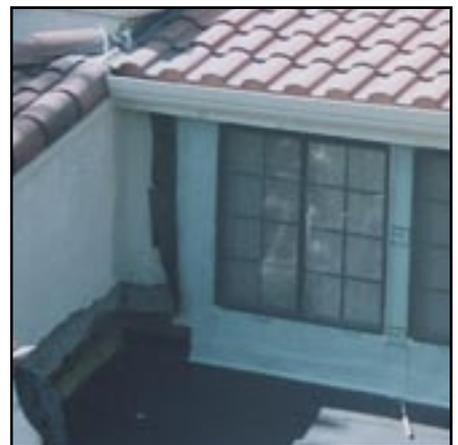
Sectional rebuild

Perhaps the most common type of stucco repair involves removing sections of stucco around windows or flashing transition areas, then applying new flashing, wire reinforcement and plaster. This technique requires meticulous and intensive labor during the demolition and reapplication process. It should include using bituthene pliable membrane at all corners, horizontal surfaces and flashing transition areas. The cost to rebuild three or four flashing transition areas within the same 20-foot by 20-foot section of stucco may cost between \$3,000 and \$12,000 depending upon the quality of the repair. Doing the job right takes time, which is why this method has the highest failure rate of the three options. In a poorly done rebuild, the new paper flashing is not entirely lapped under the salvage edge of the old paper, and often the lathe wire reinforcement is compromised.
