# DEALING WITH DECK AREA LEAKS

By Charles Antis

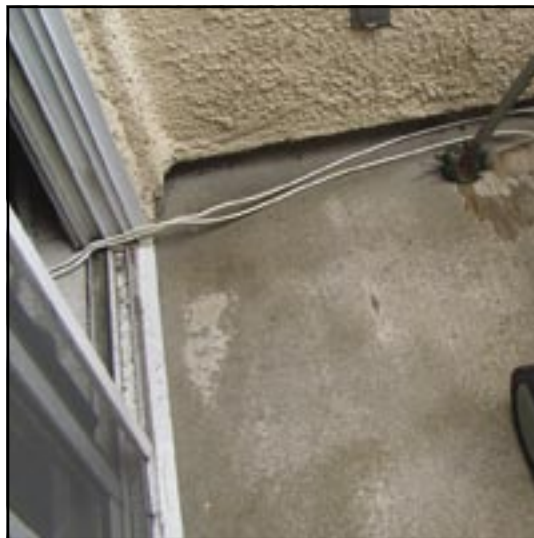
**1: Thresholds**

Decks have an access door, which is generally a sliding door on an aluminum frame. These frames are built much like a picture frame and commonly fail at the lower mitered corner joints. Repair requires temporarily dismantling the door, reinforcing the

failing joints and improving drainage of the threshold system.

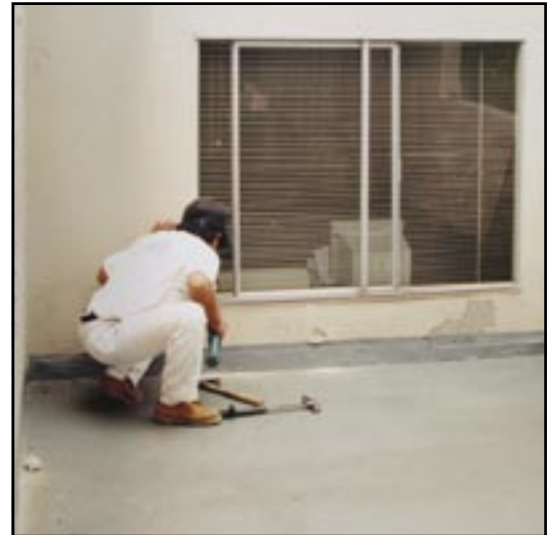
**2: Wall flashing**

Hose bibs, electrical outlets, light fixtures and windows adjacent to the deck are the source of many deck area leaks. Even a thimbleful of water penetration at these places can show up on the ceiling below. While urethane caulking can help remedy wall leaks, it is sometimes necessary to rebuild the poorly-flashed walls. In the case of stucco walls, they may have to be coated with elastomeric coatings.

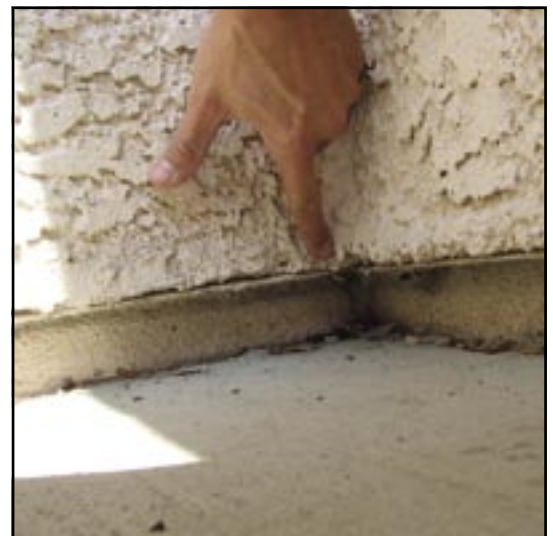
**3: Base-metal, perimeter-flashing**

Decking must be separated from perimeter walls using metal flashing. Where this flashing meets door-frames or other transitions is a common place for leaks. As with wall penetration leaks, leaks around flashing may require reconstruction or elastomeric coating to remedy the situation.

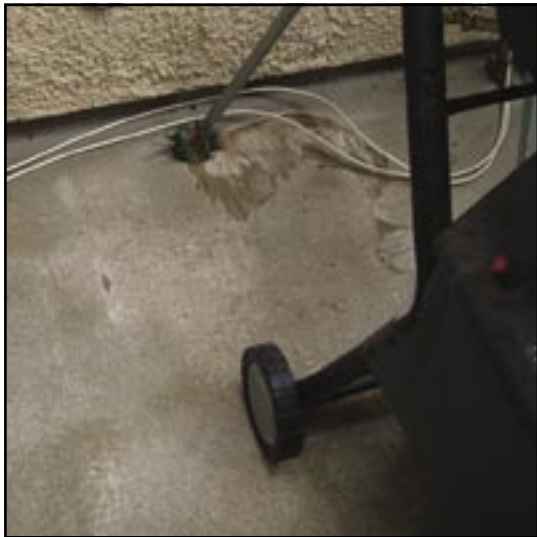
**4: Decking membrane failure**

When a deck is failing, it is usually quite evident. Failure can be caused by nail heads penetrating the deck surface, large splits in the membrane, or delamination (separation of the laminated layers of the decking material) at the perimeter metal flashing. When a decking system fails, the entire decking system must be replaced. Patching is not an effective solution for aesthetic and performance reasons. When replacing the deck, a fully adhered system (such as urethane decking or fiberglass/acrylic) per-

forms better than a “slip-sheet” system, in which paper or polyester sheeting separates the membrane and decking material. In an association with deck area leaks in multiple homes, I recommend completing the decking replacement on the entire complex at one time. Spot replacement may result in inconsistent finished quality and a much higher price per square foot.
