SIMPLE SOLUTIONS FOR LEAKING WINDOWS

By Charles Antis

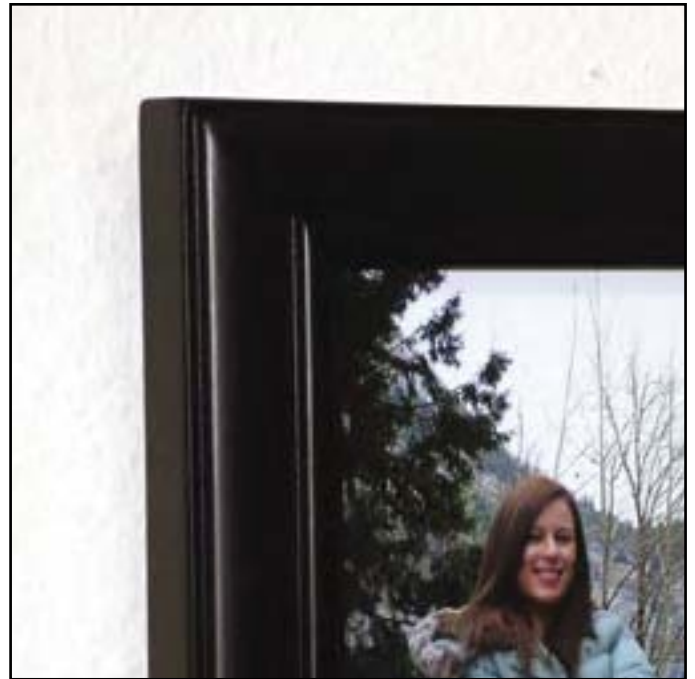
Picture frame

Let's examine the components of an aluminum sliding-frame window. The best way to conceptualize the window frame is to compare it to a picture frame, like the one hanging on your living room wall. Notice the corners are cut at an angle and fastened and/or glued together. The aluminum frame on your window or

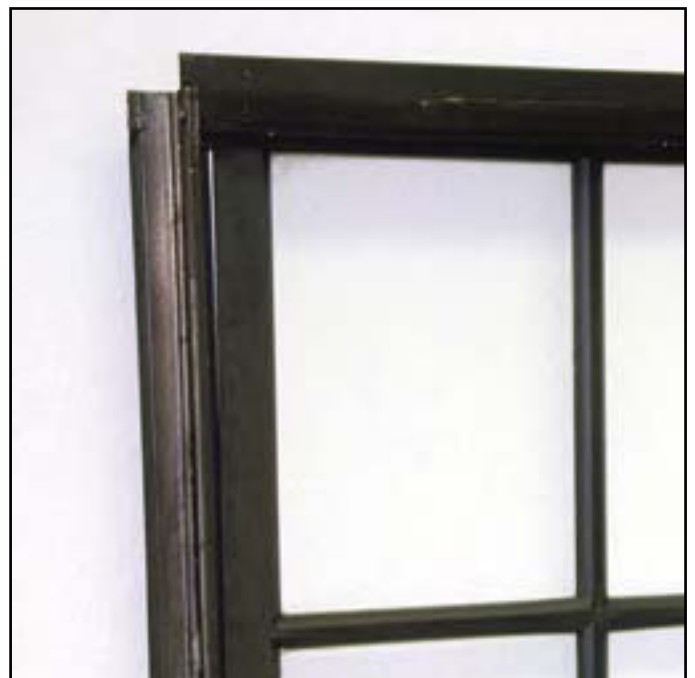
Window frame

sliding door is built the same way. A mitered corner is screwed together and then glued with butyl rubber. The design of this window or door allows water to enter the inside of the mitered corner joint, causing many aluminum-framed windows and doors to leak.

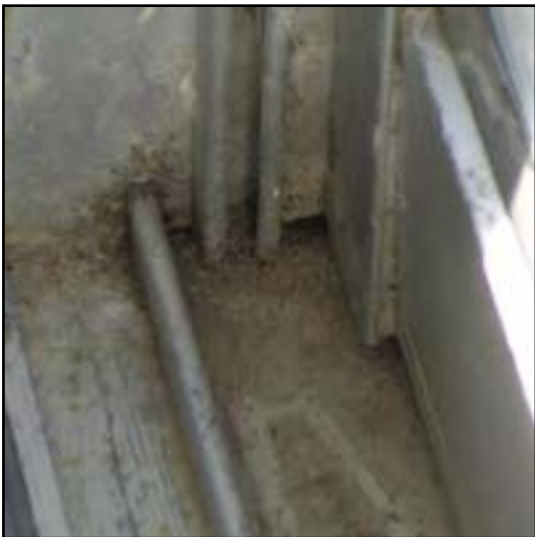
Failing corner joint

Sealant failure is exacerbated by the fact that windows and doors are seldom truly level. They are either bowed from the middle to the corners or one corner is lower than the other. This happens due to poor installation, house settlement or sagging in load-bearing walls. When a corner sits lower than the rest of the frame, it causes the rainwater to pool at the lower ends and leak into the wall cavity from the tiniest imperfections in the frame. Water damage usually shows up on the sill plate, on the carpet or in the wall of the ceiling directly below the leaking

Since most window leaking is traced to failure at this location, it is critical that a reliable seal is facilitated. Factory sealants often consist of butyl rubber, which can eventually delaminate and

fail. In order to allow for a complete mitered corner seal, it is critical that the window be disassembled and all unnecessary extruded metal be removed from the corner on the jamb and sill plates. The entire corner is then wire-brushed and resealed using low-module urethane rubber.

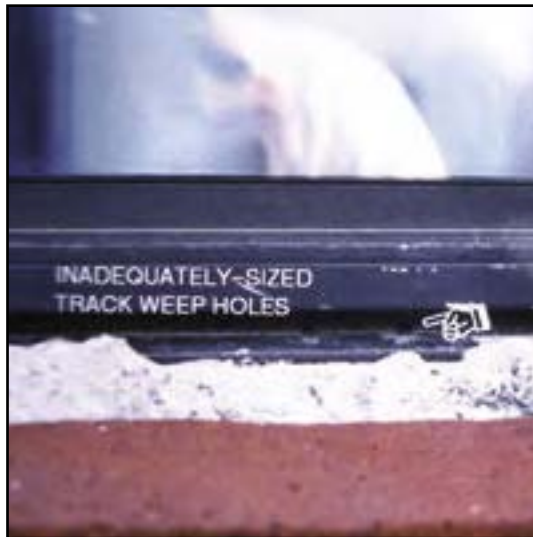
Weep holes

window. Another exacerbating factor occurs when weep holes are clogged or poorly positioned. Weep channels or holes are the little cutouts in the frame that allow the trapped moisture to “weep” back out onto the exterior wall or patio deck.

Factory-installed weep channels are often inadequate in size or they are positioned away from the corners where leaking occurs. By installing new quarter-inch weep channels a half inch from the corners, proper drainage is facilitated.

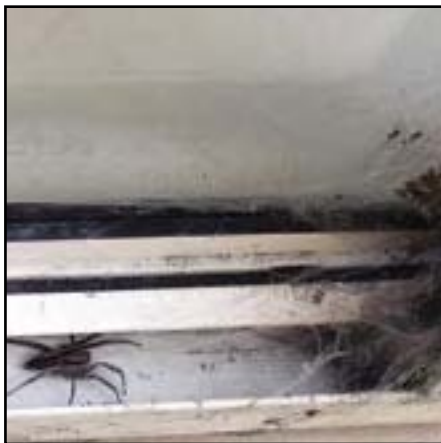
Debris in the window track

Debris caused by corrosion, dust, silt from stucco, bugs and dilapidated sealants often impede water flow within the tracks and blocks the factory-installed weep channels. The simple act of vacuuming out the tracks can help facilitate better window drainage.

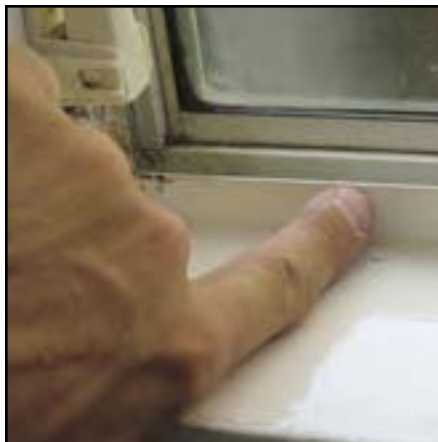
Dam bar

When window rehabilitation fails in eliminating leaking, it is often because the dam bar is not properly sealed to the jamb plate. This vertically extruded, 1-inch-high section of the sill plate on the window frame creates the dam that keeps the rain water within the frame from dripping onto your sill. It is critical that both ends of this frame be properly cleaned and sealed to the vertical sections of the window frame.

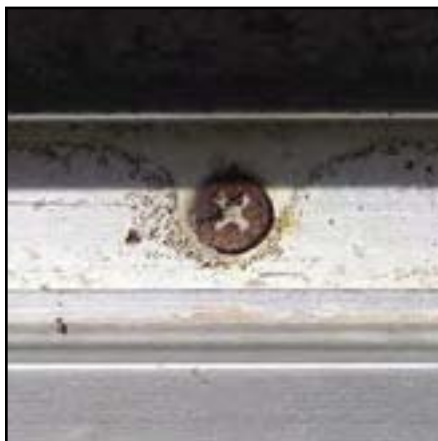
Mounting bolt

When the sliding window section is removed, mounting bolt penetrations or alarm installation penetrations are often visible within the bottom of the window frame. All penetrations must be completely sealed or leaking will occur.
